## **OFFER LETTER**

**RE: M/V ANAPAYA – Ladysmith, B.C.**  
**Incident date: 2017-10-21**

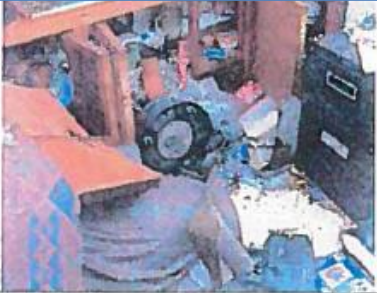
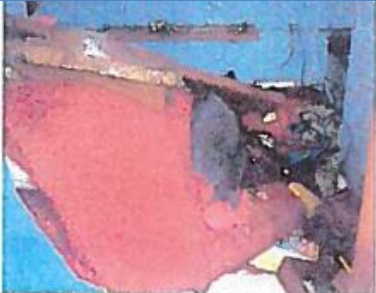
<p>11/3/2017 Change out absorbants as required. Oily substance coating interior walls, floor and debris inside of the vessel. Additional clean up required.</p>	<p>11/03/2017 Change out absorbants as required. Oily substance coating interior walls, floor and debris inside of the vessel. Additional clean up required.</p>

The document labelled “Vessel ‘Anapaya’ 2017 photos” was prepared by Saltair Marine as part of its contracted work on the project. Pages 6 through 11 of this document display photographs, along with captions, which are replete with depictions of the oily state of the ANAPAYA on November 2, 2017 (i.e., after she was raised). There is documentation of an oily substance throughout the vessel, as well as buckets of oily materials found inside the ANAPAYA’s living spaces. The Fund has determined that the Saltair Marine document establishes that the ANAPAYA was extensively polluted. In the circumstances, the decision to deconstruct the ANAPAYA was therefore reasonable.

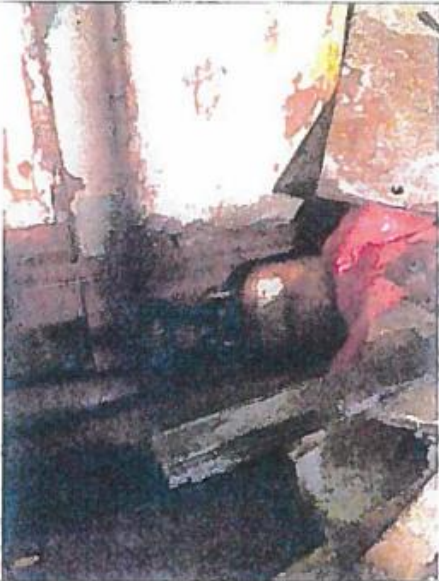
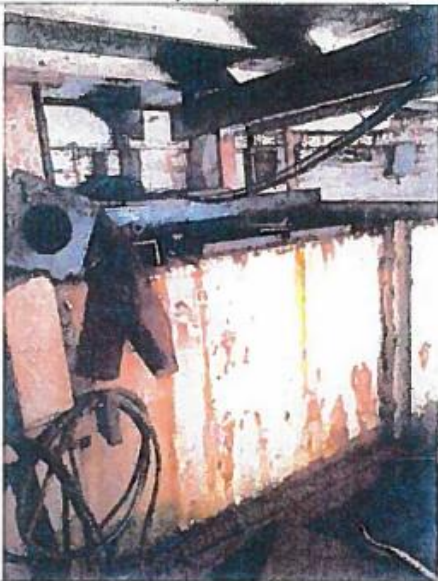
Figure 3 - Excerpt from page 7 of the document "Vessel 'Anapaya' 2017 photos"

<p>11/3/2017 Change out absorbants as required. Oily substance coating the inteior of vessel and debris. Propain tank requirceing to be removed. Additional containment and clean up required.</p>	<p>11/3/2017 Change out absorbants as required. Fuel tanks in haul of vessel. Above decks and debris requiring to be removed to safely pump remove fuel tank. Oily sludge and debris under tanks required additional containment and clean up.</p>
